University of Toronto - Civil & Mineral Engineering
CIV280F Management of Construction - Course Project
Team members: Maher Absar, Vincent Lai, Alex Vespa
Date: November 14, 2018

Project Information	Project Name	Dundas Square Gardens
	Description	High-Rise Condominiums (Residential), Currently at 30 Floors Building Up Additional Floors [1]
	Location	200 Dundas St. E., Toronto, Ontario
	Owner/Developer	The Gupta Group (Owner), Easton's Group (Developer) [2]
	General Contractor	SkyGrid [3]

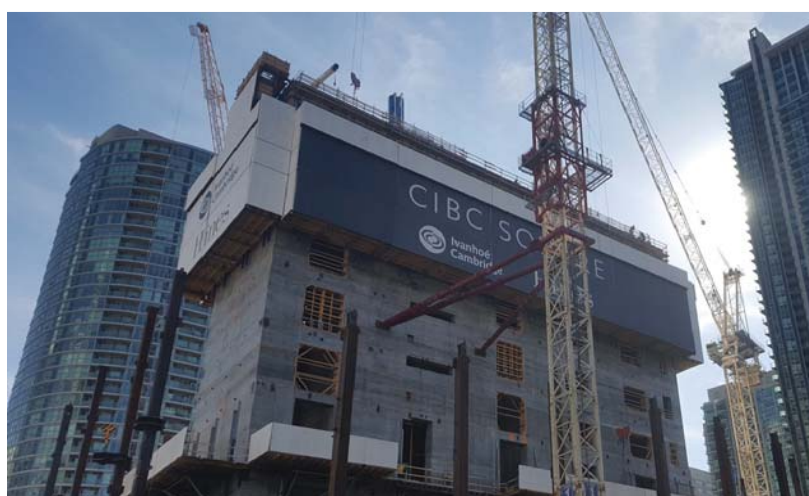
After excavation is complete, the foundations are laid and then the building itself can be built. In order to move materials around the site, cranes are typically used [5]. The most common types of tower cranes seen were hammerhead cranes and luffing cranes. Though hammerhead cranes are more efficient in moving materials than luffing cranes, they can only be used when there is ample space [5]. This is because it has a greater swing radius than a luffing crane, and is more likely to interfere with adjacent structures [5]. Hammerhead cranes were used at 100 Queens Quay East, and Tucker HiRise. Conversely, when there are impeding structures close to the site, a luffing crane is used [5]. For example, three luffing cranes were used at CIBC Square because of the adjacent Gardiner Expressway, as seen in Figure 2 below.

Figure 2: Three Luffing Cranes in the Foreground and Background at CIBC Square [8]

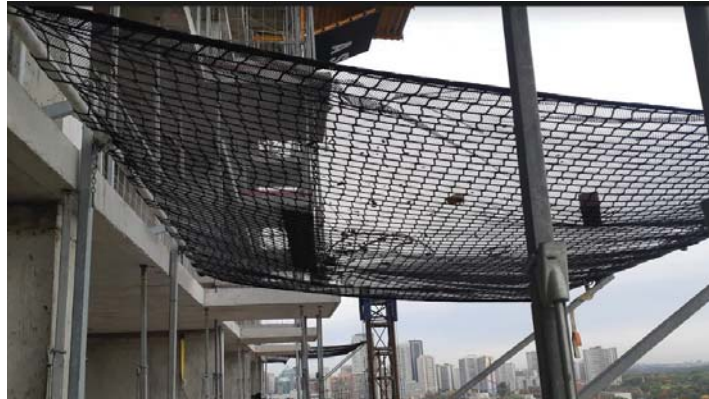
In terms of safety related to building up, a unique feature of Dundas Square Gardens is a safety net. The safety net is used to catch materials that may fall off the building during the construction process. This is mainly to protect workers on the ground floor, as well as pedestrians [1]. Figure 3 below shows the implemented safety net, which has caught bricks and other debris.

Figure 3: Safety Net at Dundas Square Gardens to Catch Fallen Materials and Debris [8]

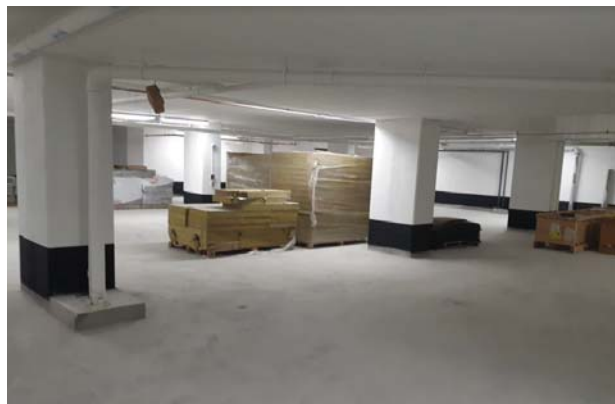
The planning of the organization of materials and labour is key to process efficiency and keeping a project on schedule [1]. Organizing materials to ensure that workers can find the materials quickly can increase efficiency because they are not wasting time looking for the materials they need [5]. At Dundas Square Gardens, most materials were kept in the underground parking lot in neat piles so that the workers knew exactly where to find them [1]. This can be seen in Figure 4 below. As well, safety is increased because unused materials are kept out of the workers' way [1]. Generally, most sites had their materials on the ground floor, but in neat and separate piles nonetheless.

Figure 4: Materials Stored Underground at Dundas Square Gardens [8]
